#### PORTER ARRROYO DETENTION FACILITY PROJECT # 02-08 CONTRACT CONTROL 14-102822

#### ADDENDUM THREE

#### MARCH 19, 2014

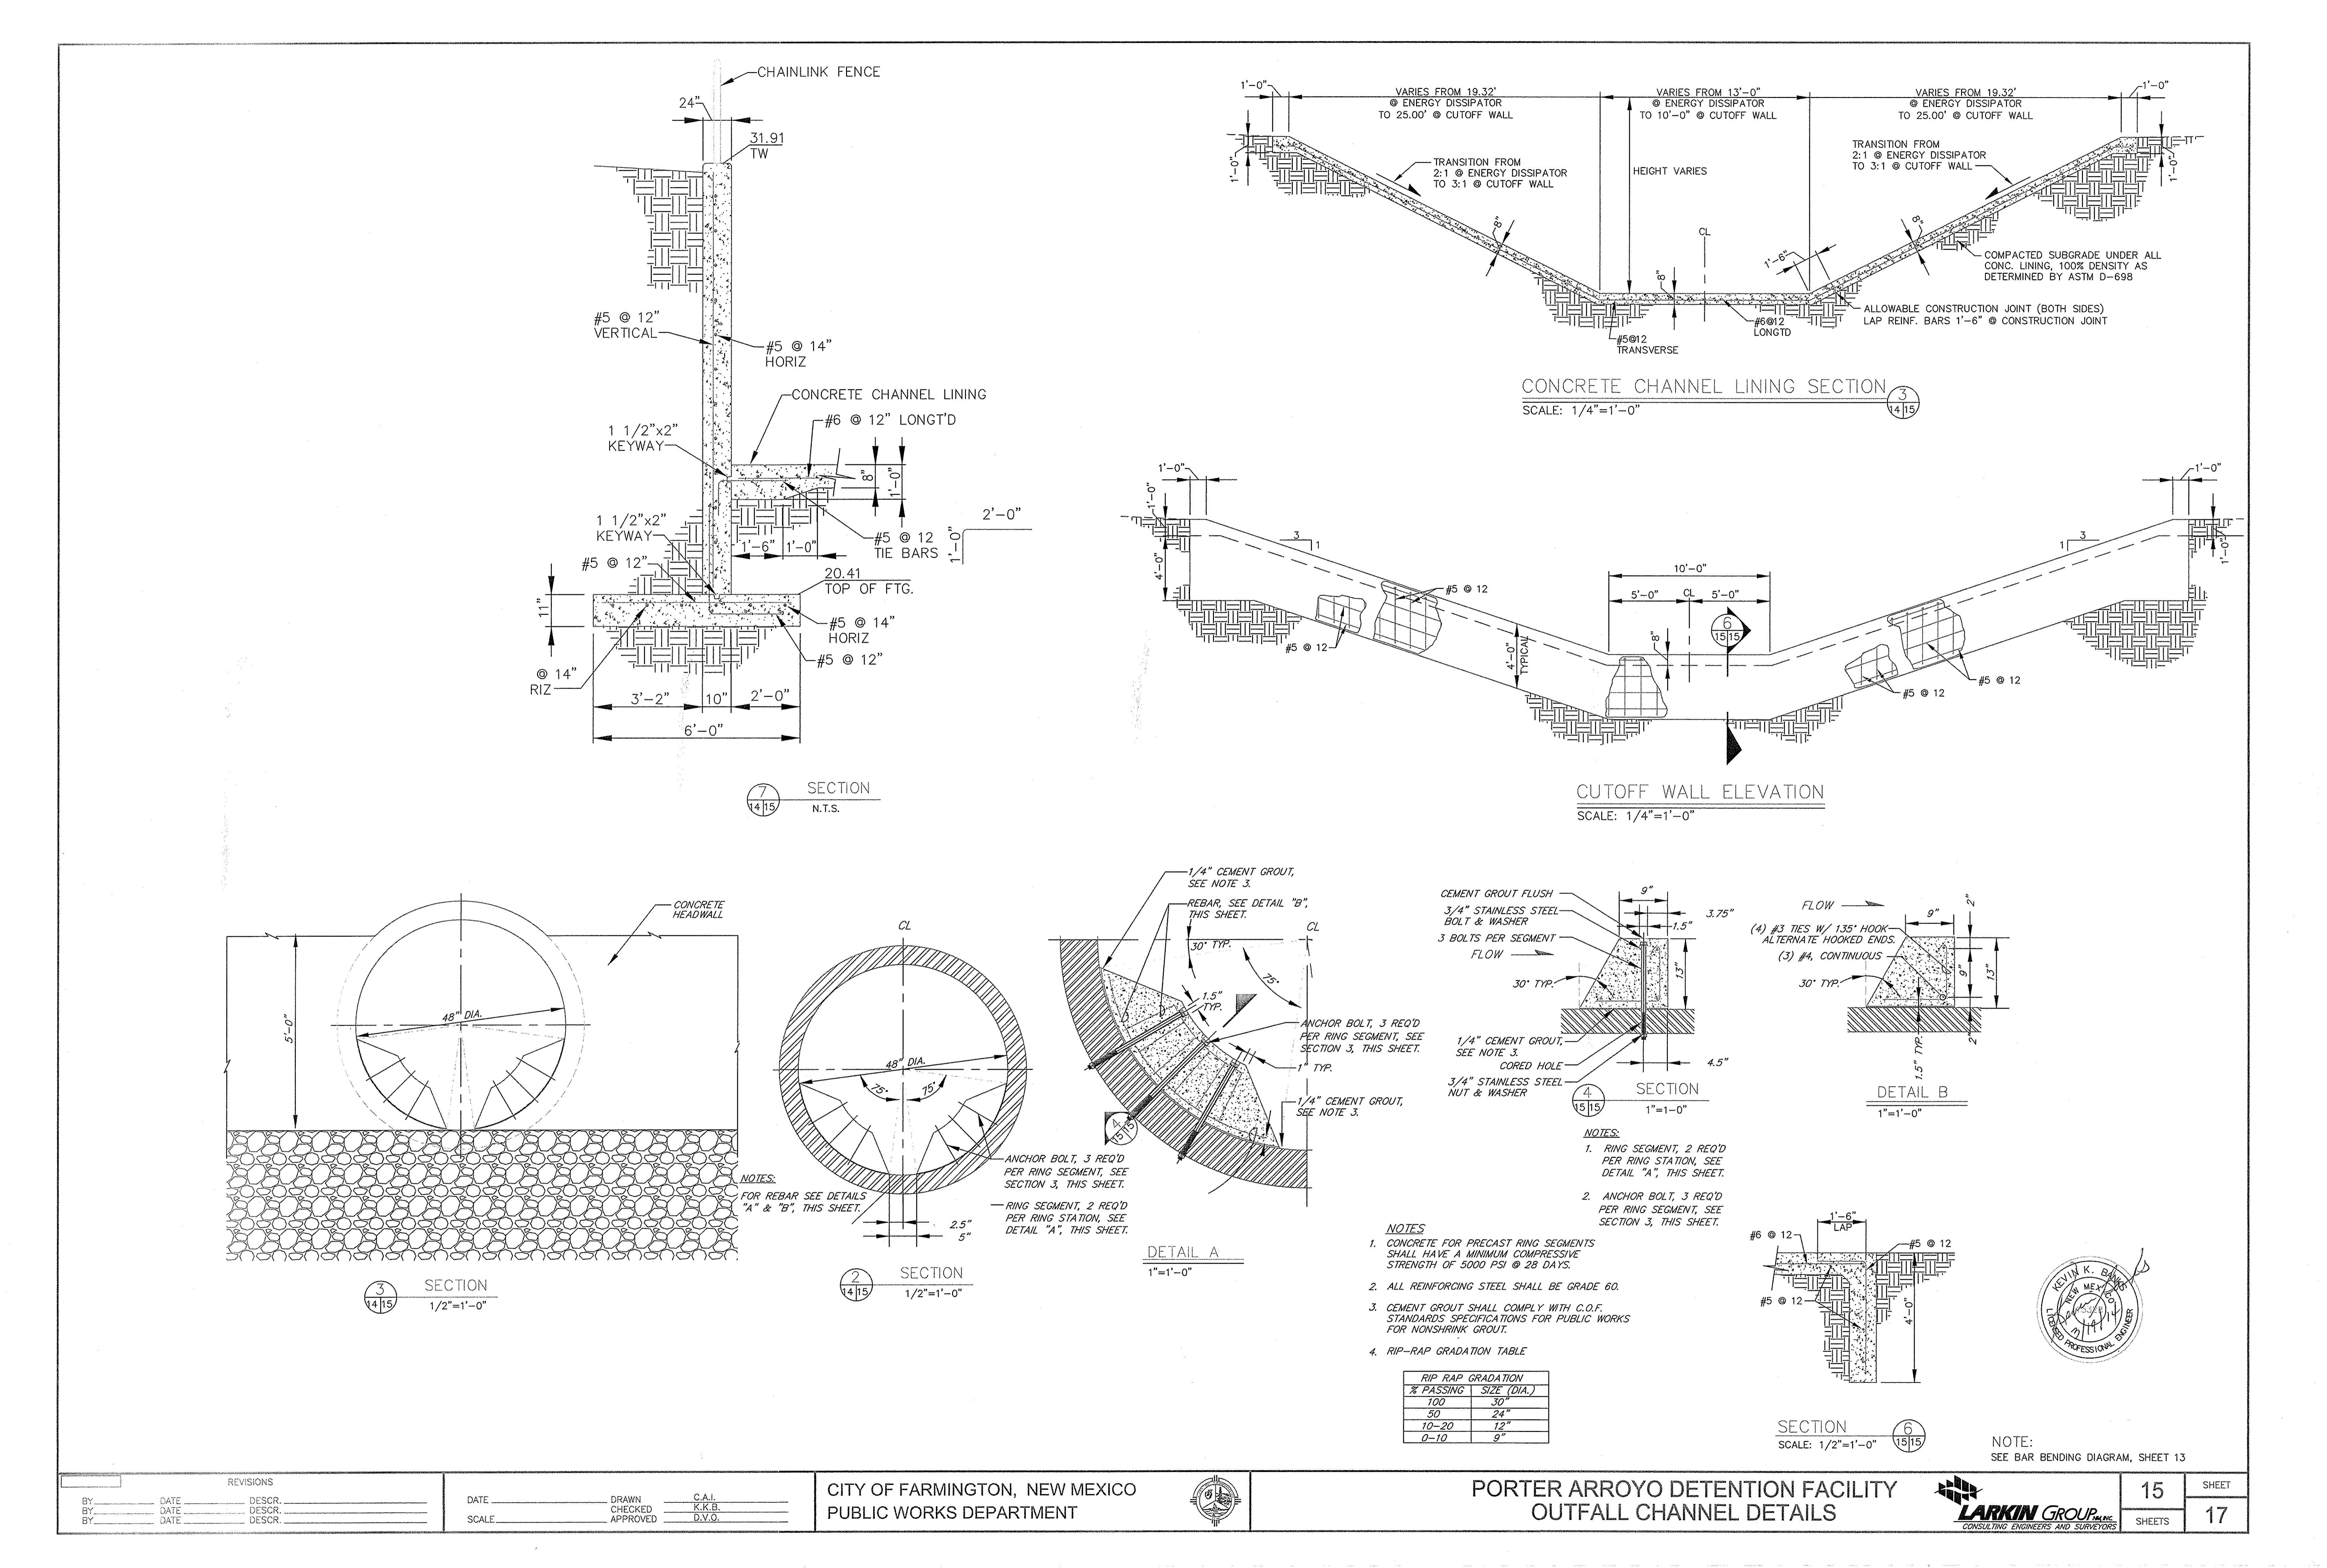
- 1. Detail 7 on Sheet 15 of 17 has been cut-off. We can't see the entire footing detail, and I think some text has been cut off on the right side. Please provide a complete detail. Sheet 15 of 17 has been revised to show the complete detail. The revised sheet is <u>attached</u> with this addendum.

- 2. Section 1 on Sheet 14 of 17 shows the headwall to be 6'-0" tall. Detail 7 on Sheet 15 of 17 shows the wall to be 11'-6" tall. Please clarify. *Detail* 7 shows a general cross-section of 2' spacing between the bottom of the channel and the wall footer. The height of the wall however will vary, depending on the existing ground level. This applies to both the spillway and the outflow channel.

- 3. Please clarify the length and height of the headwall. Does the wall extend the entire width of the concrete lined channel? Is the wall the same height for its entire length? The Erosion Control Wall referred to for this question will be 11'2" above the 1' footer thickness. The detail for the Erosion Control Wall on sheet 16 shows the height at the channel flow line to be 4' and 11'2" at the edges where it ties into the ground. Section 3 of the Erosion Control Wall detail shows the wall above the flow line as dashed, to show that it is buried at the edges. The lengths and widths of the wall are noted on the detail.
